INSTALLATION INSTRUCTIONS FOR THE REPLACEMENT

AC/DC POWER SUPPLY (TPVP103-240042)

ON MODEL AVPP-2-B-N, S/N 12083

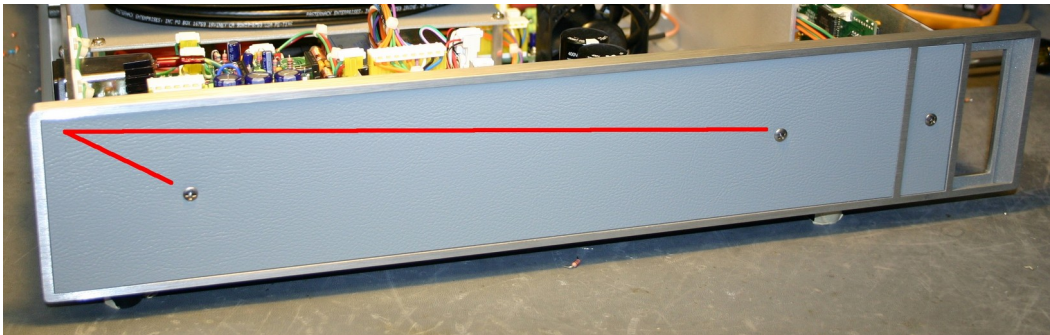
1. Disconnect the power cord from the rear panel.
2. Remove the 4 screws that secure the top cover. Slide the cover off.
3. Unscrew the 2 screws that secure the left side panel. The screw locations are shown in the photo below. Remove the panel.

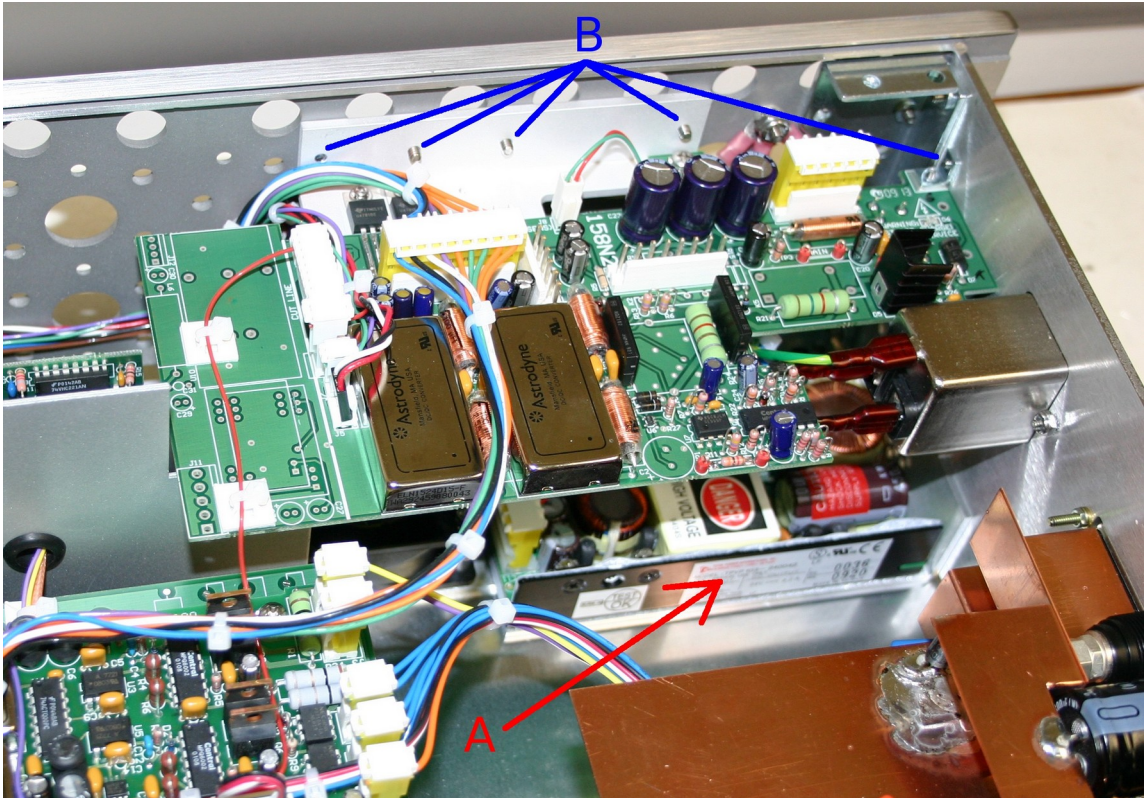
4. Locate the black Total Power TP103-240042 AC/DC power supply, labeled "A" in the photo below:

5. To access the defective TPVP103-240042 (“A”), the PCB 158N2 circuit board above it needs to be moved out of the way. Remove the 4 or 5 screws labeled “B” in the photo above.
6. Slide PCB 158N2 a few millimeters towards the front panel, so the the fuseholders come out of their punched holes in the rear panel. You should now be able to move PCB 158N2 out of the way, as shown below:

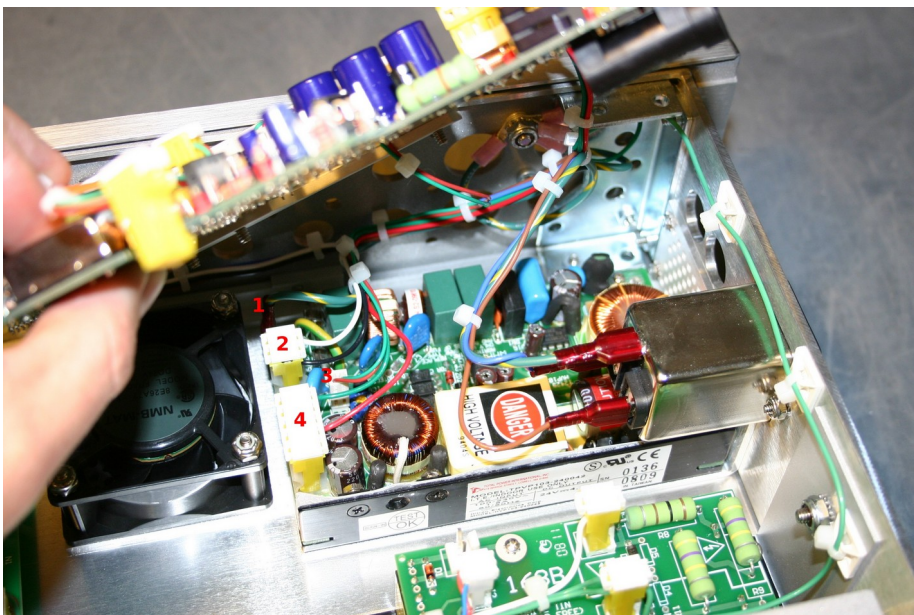
7. Locate the connectors labeled “1”, “2”, “3”, and “4” in the above photo. Slide them off of the mating connectors on the TPVP103-240042 unit.
8. The TPVP103-240042 can now be removed. Locate and unscrew the 4 screws that secure it to the bottom panel, as shown below:

9. Remove the defective TPVP103-240042. Put the replacement TPVP103-240042 in, and secure it to the bottom panel with the 4 screws.
10. Reconnect connectors “1”, “2”, “3”, and “4”.
11. Re-install PCB 158N2 by sliding its protruding fuseholders back into the matching rear panel holes. Re-install the 4 or 5 “B” screws.
12. Re-install the side and top panels.
13. Replace the two 0.5A AC fuses in the drawer below the power cord attachment point with the provided new ones.
14. Re-connect the power cord. Turn on the instrument and test it. It should be operational. If it is not, the instrument will need to be returned to the factory for examination and repair.
